**FINAL DRAFT  
SITE INSPECTION REPORT  
AND HAZARDOUS RANKING SYSTEM MODEL  
TACONIC PRODUCTS INC.  
MILLERTON, NEW YORK**

**REVISION 1, FEBRUARY 27, 1985**

**NUS CORPORATION  
SUPERFUND DIVISION**

Enclosed are the Site Inspection Report (EPA Form 2070-13) and the MITRE Hazardous Ranking System (HRS) documents for Taconic Products, Inc., Millerton, New York. The site inspection was authorized under TDD #02-8303-48A.

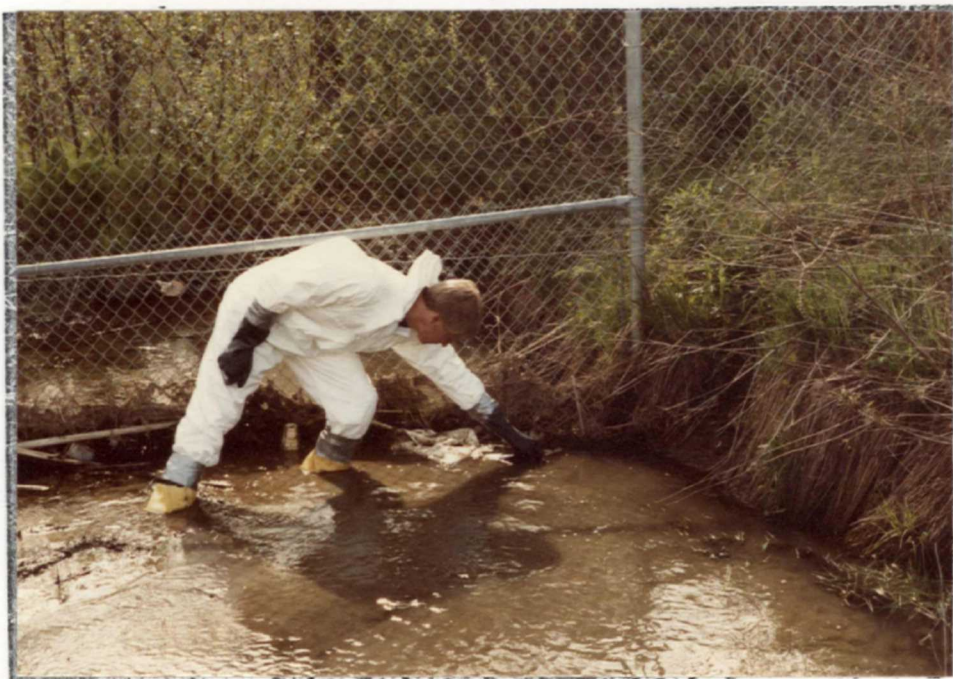
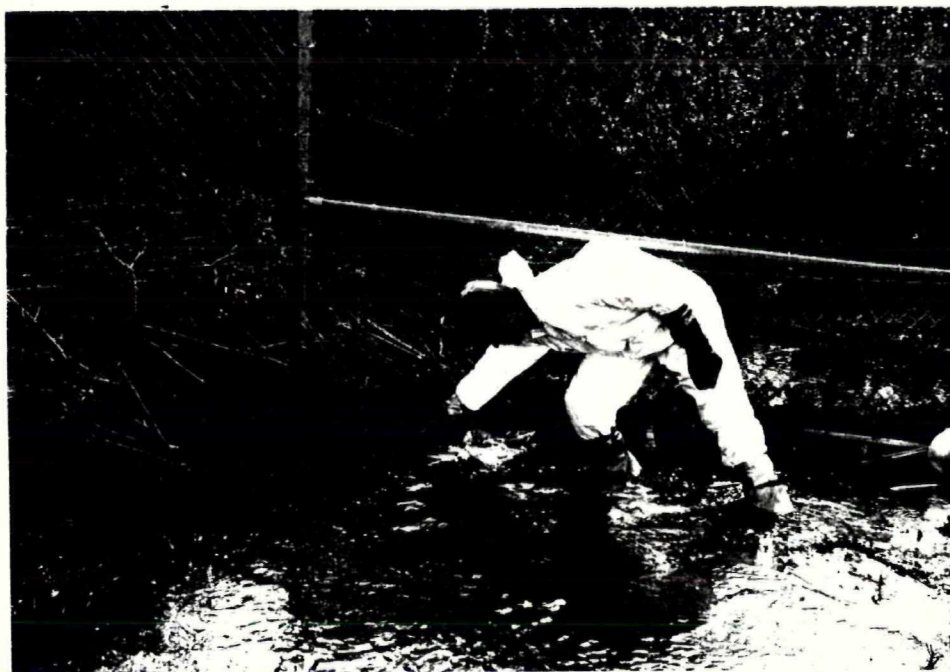
1. 5/16/84 0915 Hours Sample I.D. No. SW-1  
Surface water sample taken at the intersection of  
the stream and ditch at the southeast corner of  
Taconic Products property.

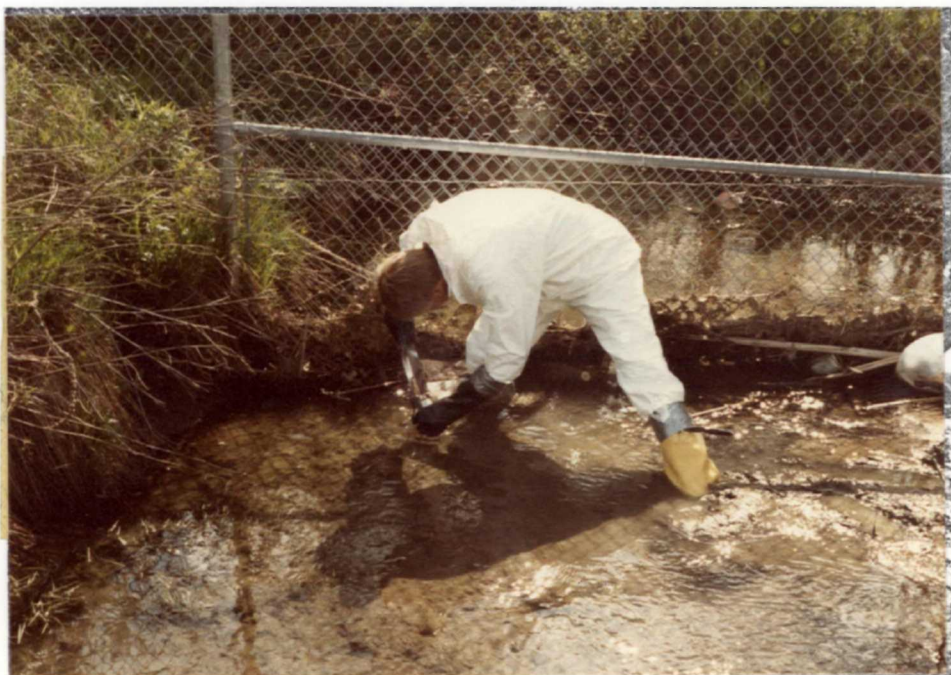
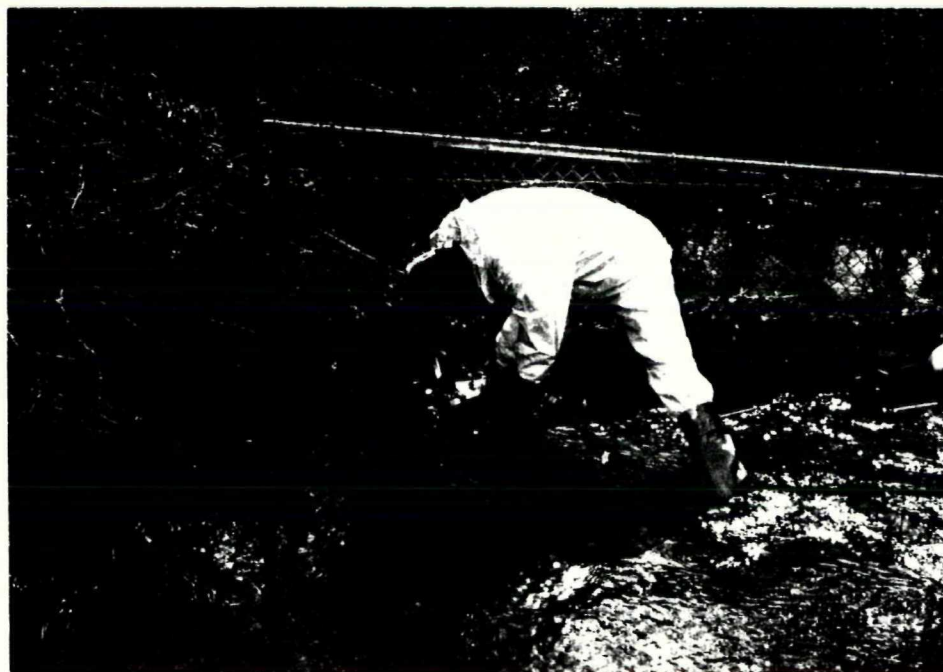
2. 5/16/84 0920 Hours Sample I.D. No. SED-2  
Sediment sample, same location as above.

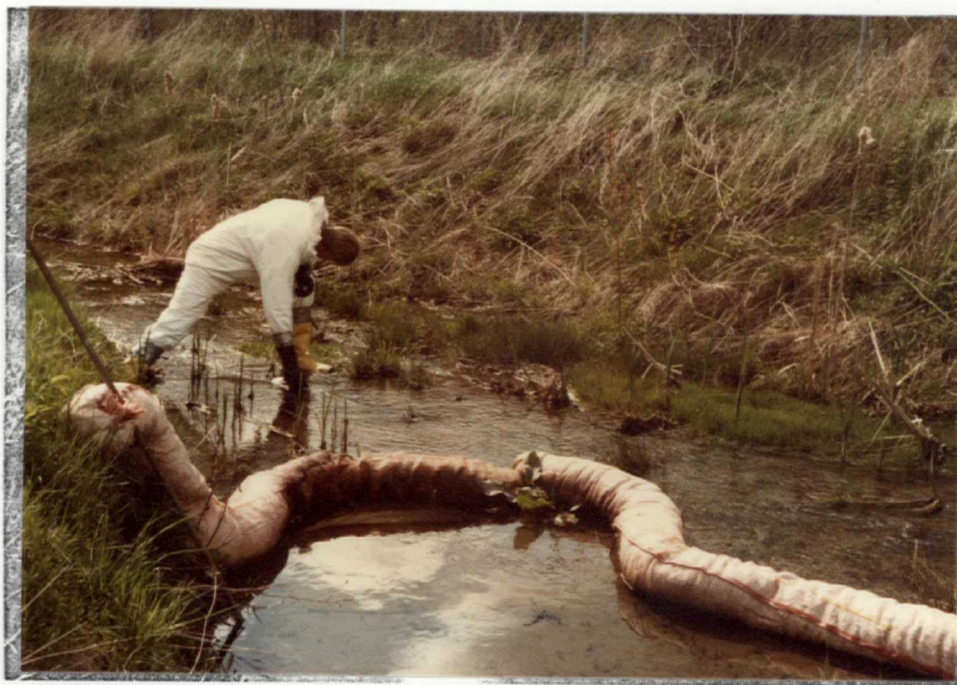
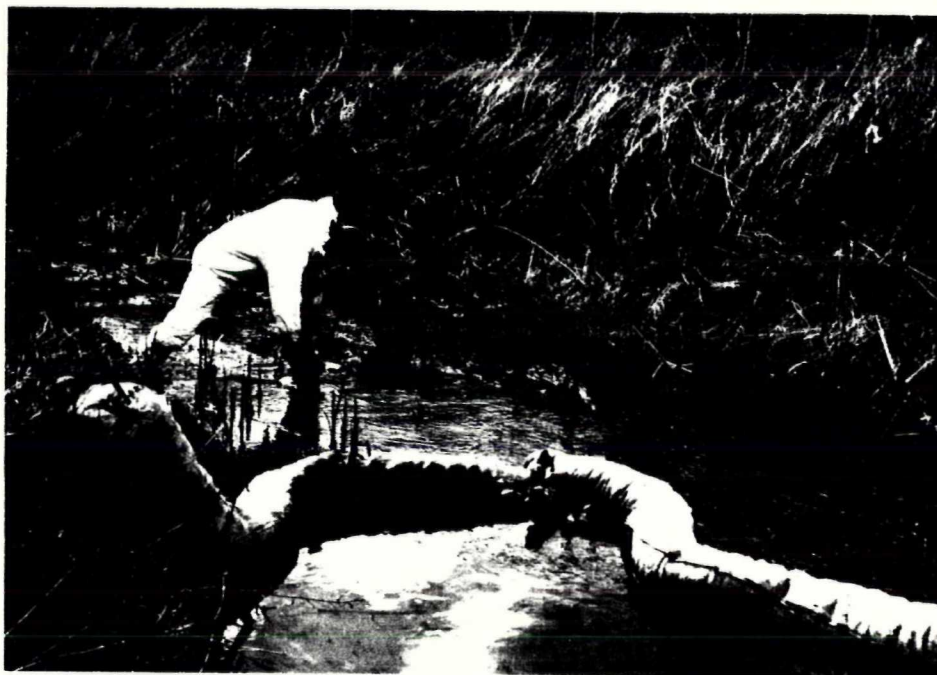
3. 5/16/84 0930 Hours Sample I.D. No. SW-2  
Surface water sample taken at the intersection  
of the stream and ditch at the southwest corner  
of Taconic Products property.

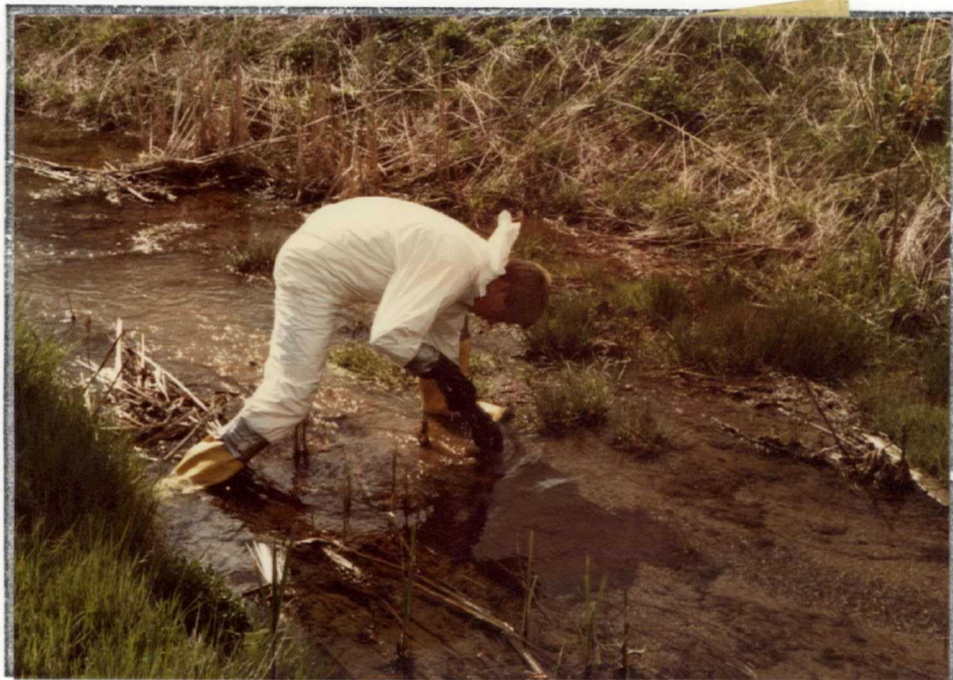
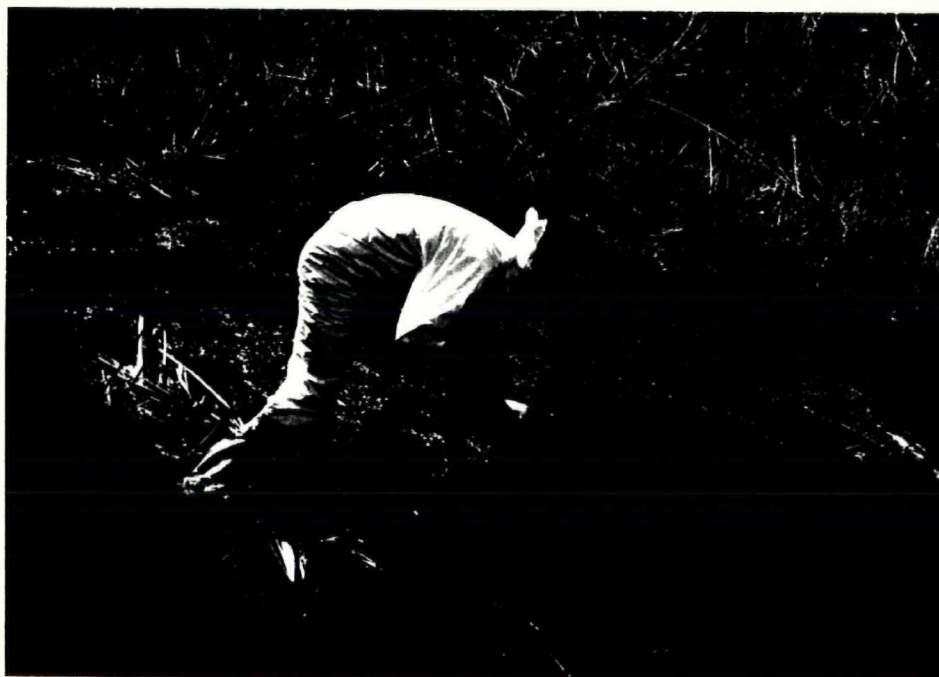
4. 5/16/84 0935 Hours Sample I.D. No. SED-2  
Sediment sample, same location as above.

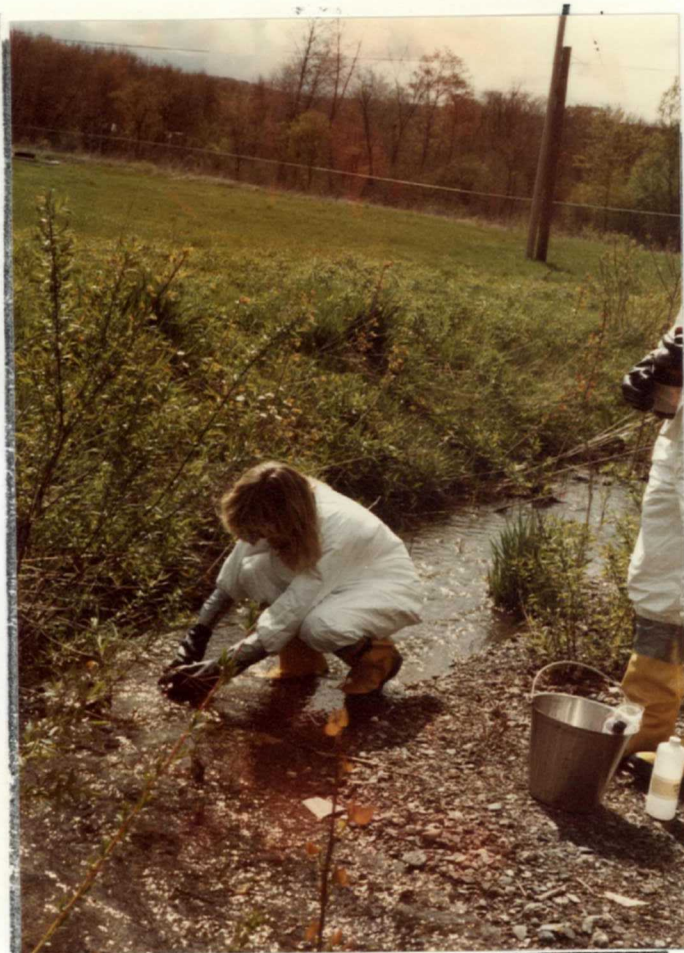
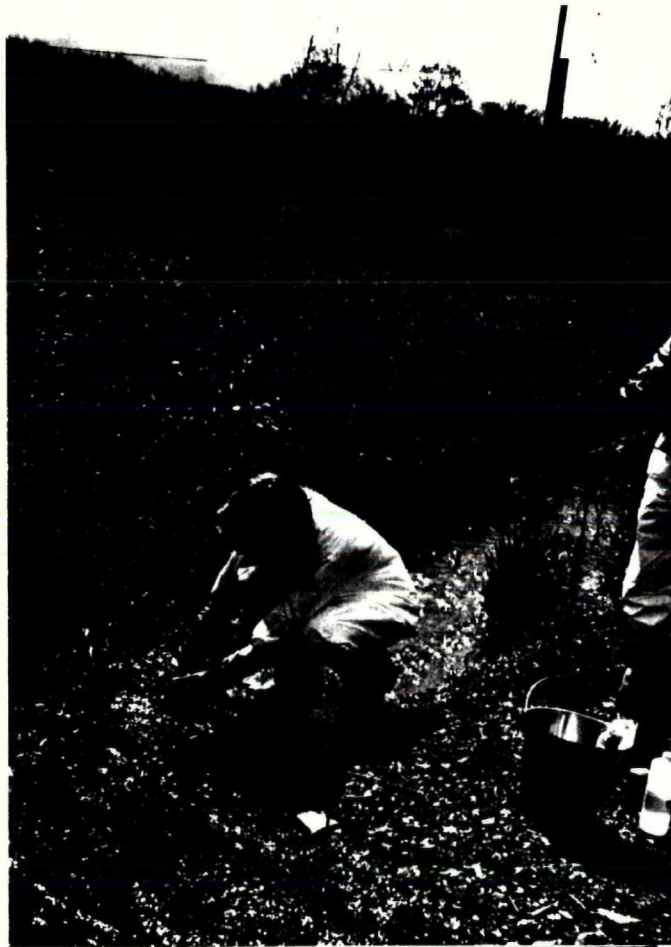
5. 6/15/84 0940 Hours Sample I.D. No. SW-3  
Surface water sample taken from the stream where  
it enters Taconic Products property, at the north-  
west corner.

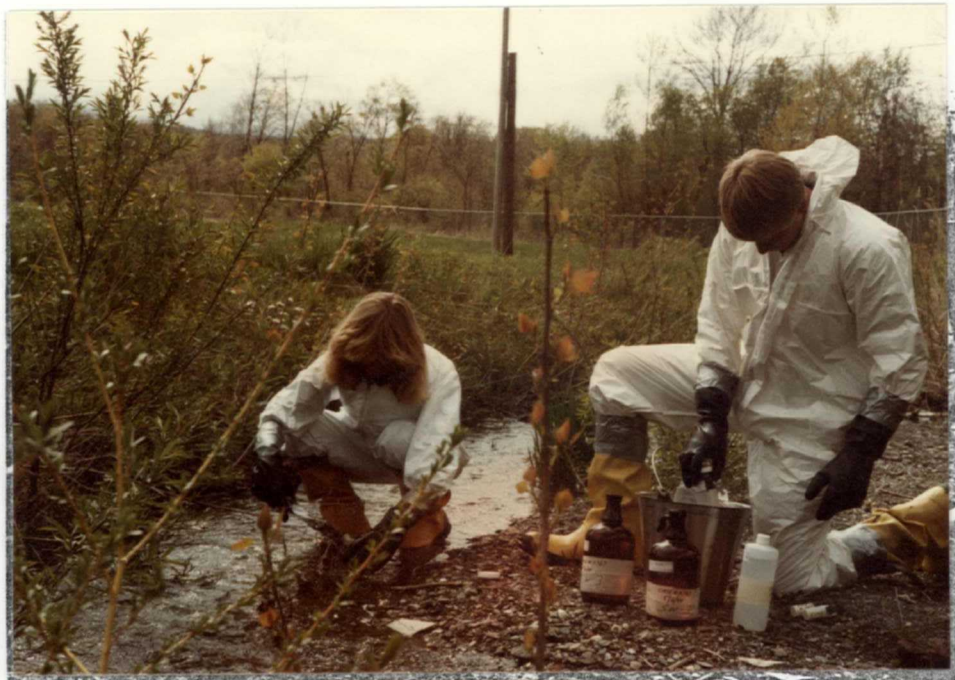
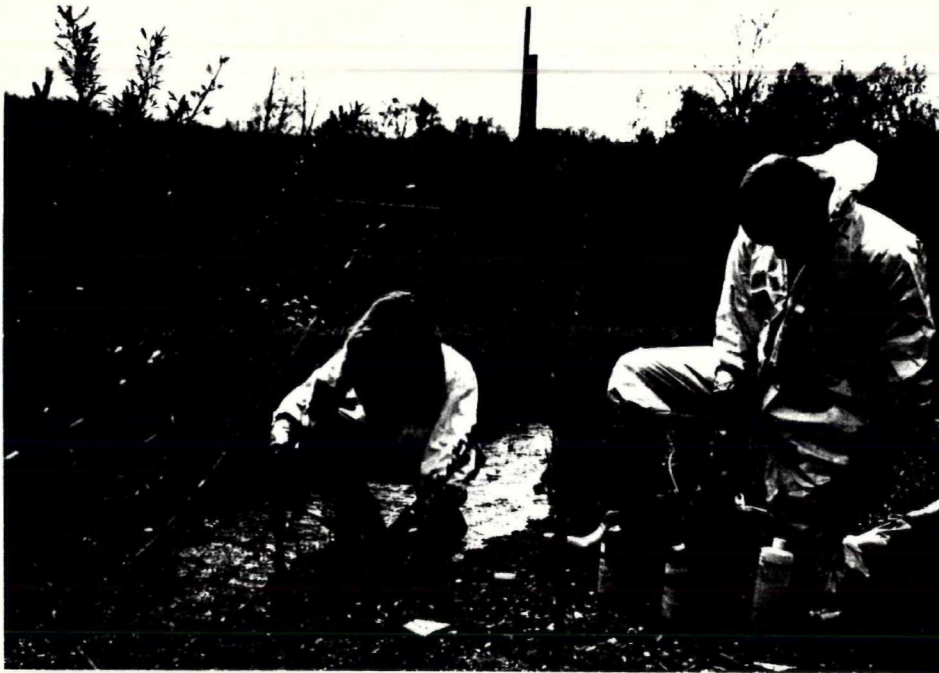
6. 5/16/84 0945 Hours Sample I.D. No. SED-3  
Sediment sample taken from the stream where it enters Taconic Products property at the north-west corner.

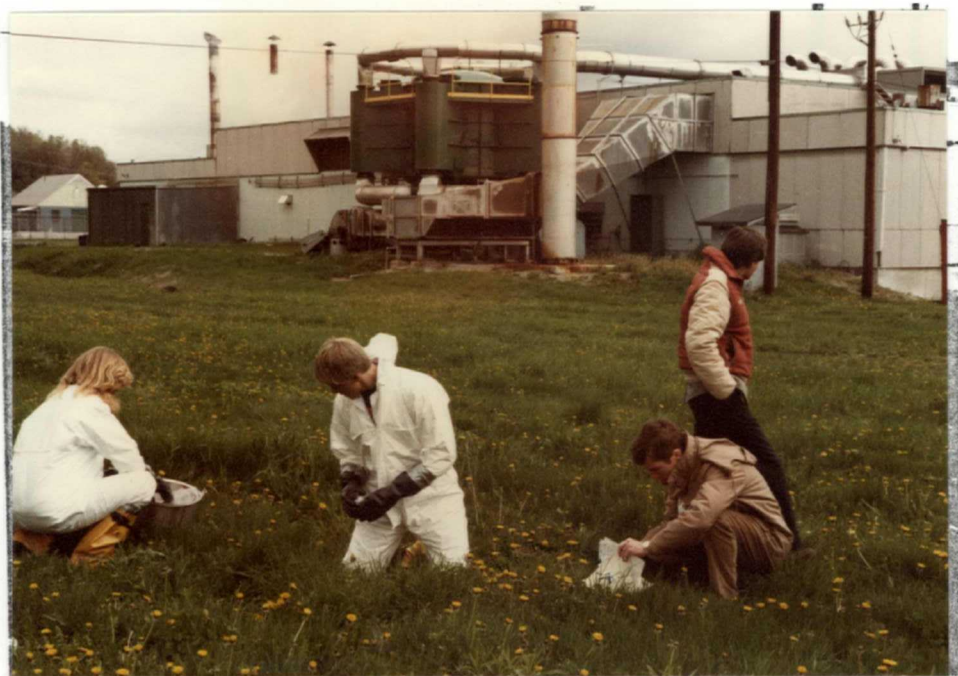
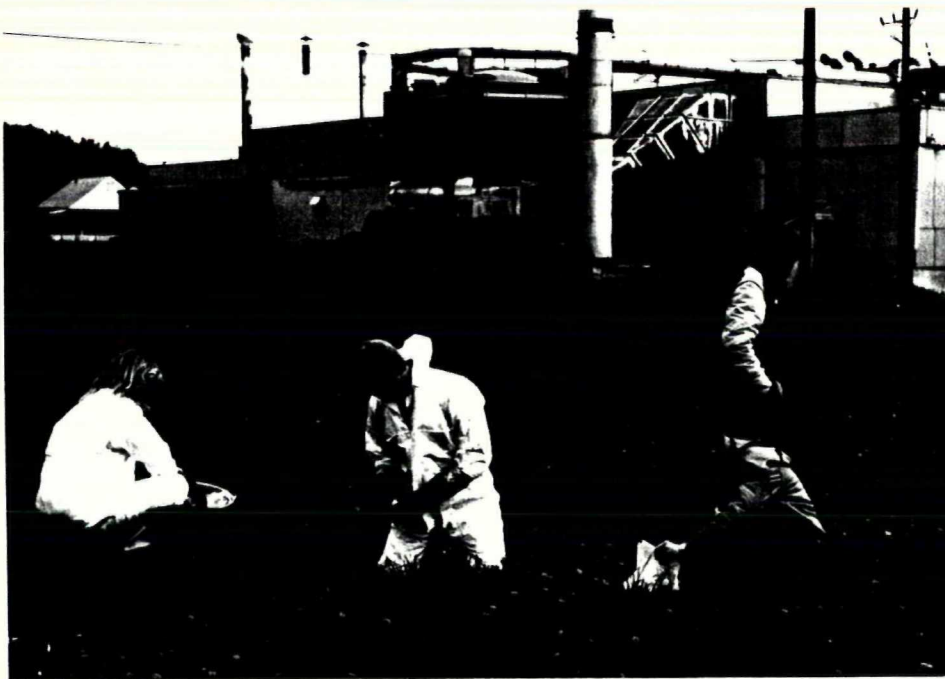
7. 5/16/84 0955 Hours Sample I.D. No. SOIL-1  
Surface soil sample taken from the southern area of the former incineration area.

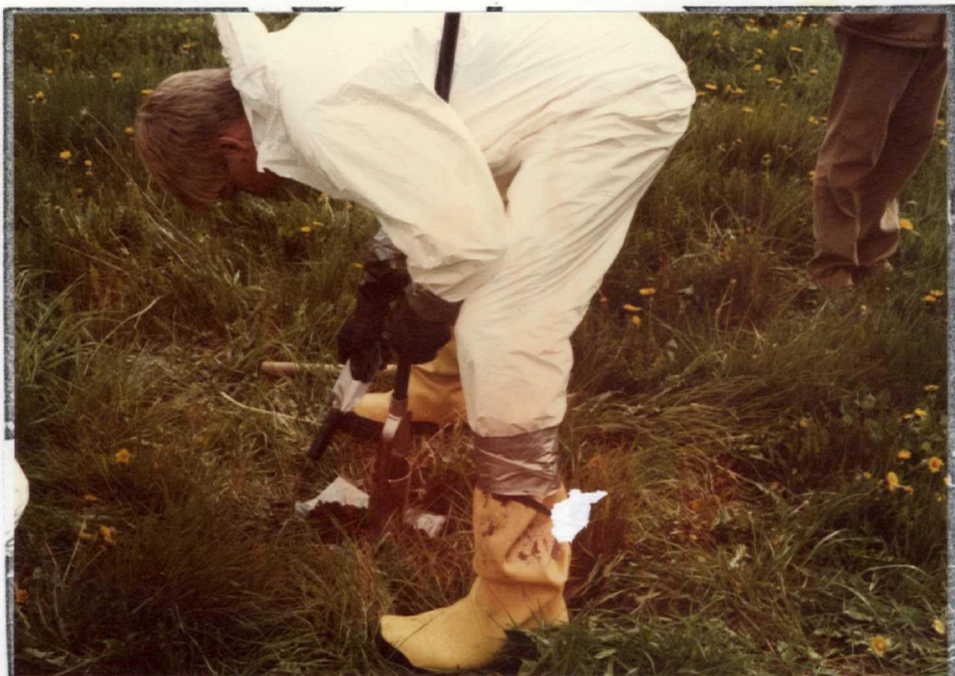
8. 5/16/84 1000 Hours Sample I.D. No. SOIL-2  
Subsurface soil sample taken from the southern  
area of the former incineration area.

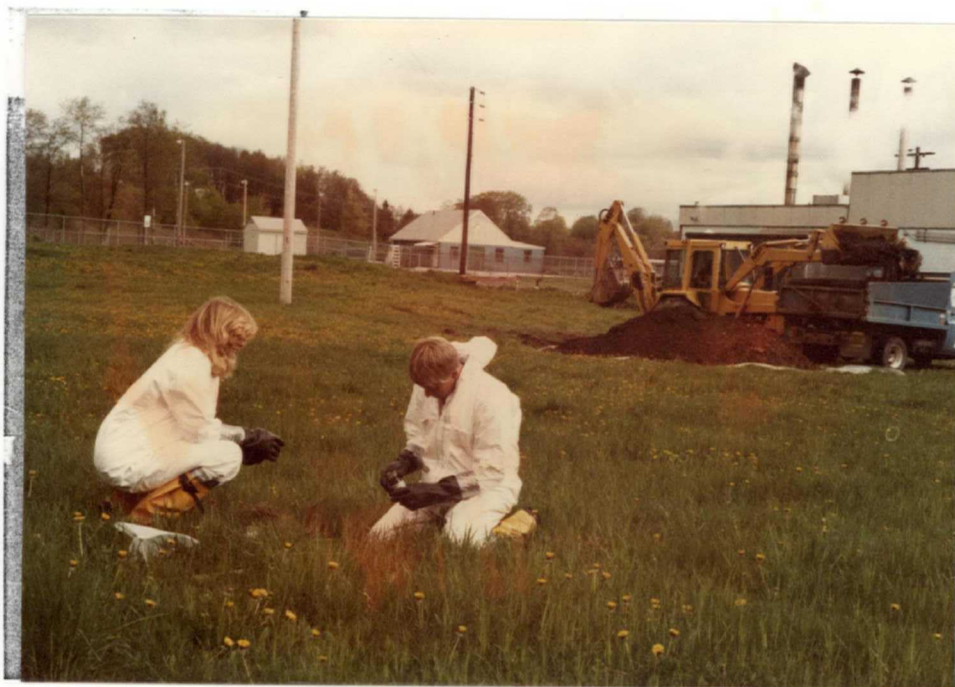
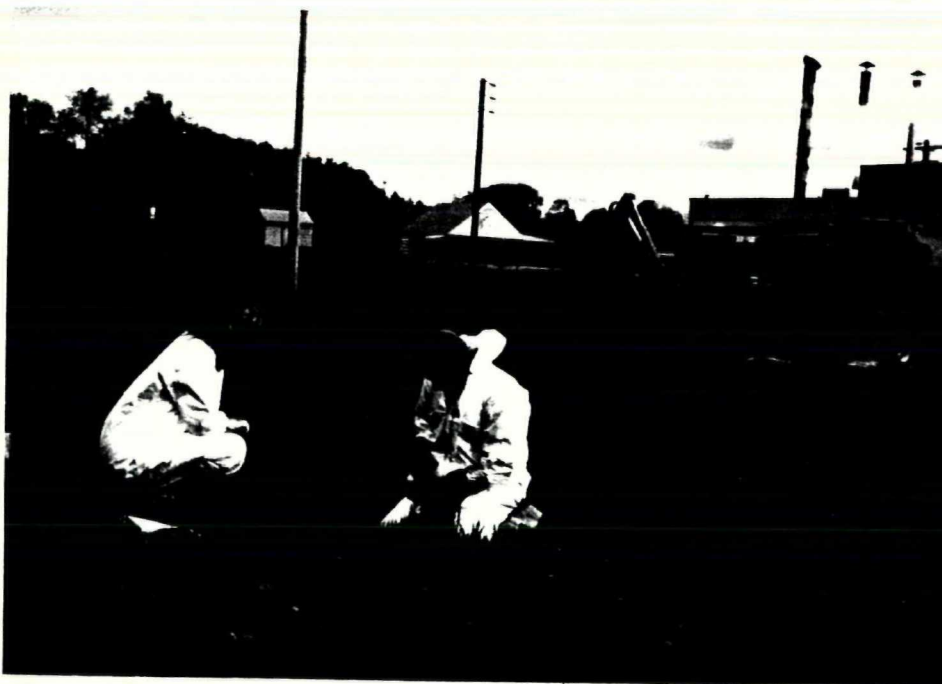
9. 5/16/84 1005 Hours Sample I.D. No. SOIL-3  
Surface soil sample taken from the northern area  
of the former incineration area.

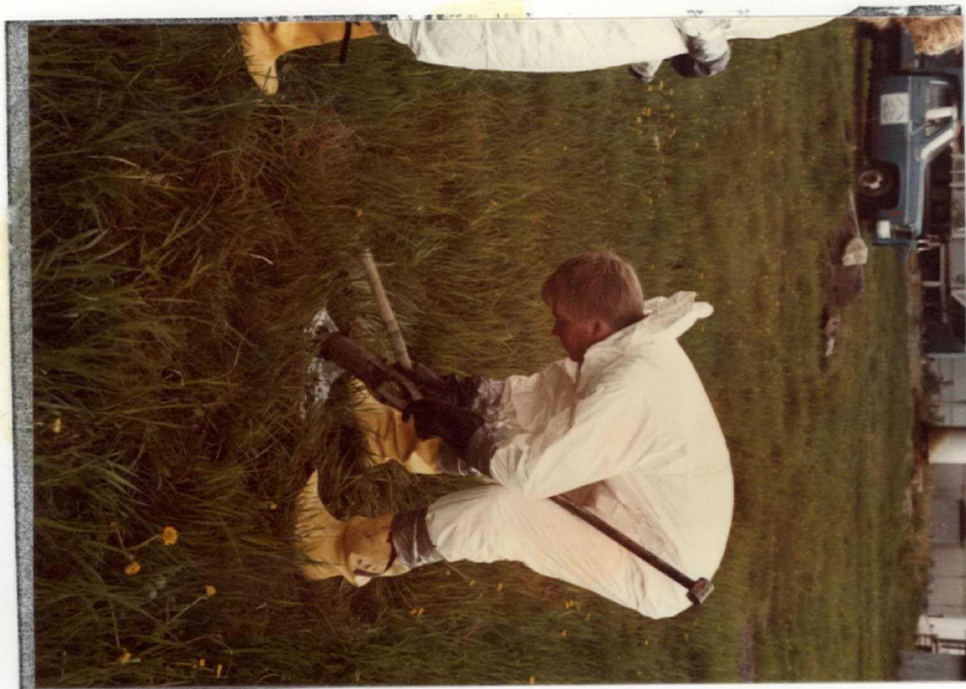
10. 5/16/84 1012 Hours Sample I.D. No. SOIL-4  
Subsurface soil sample taken from the northern  
area of the former incineration area.

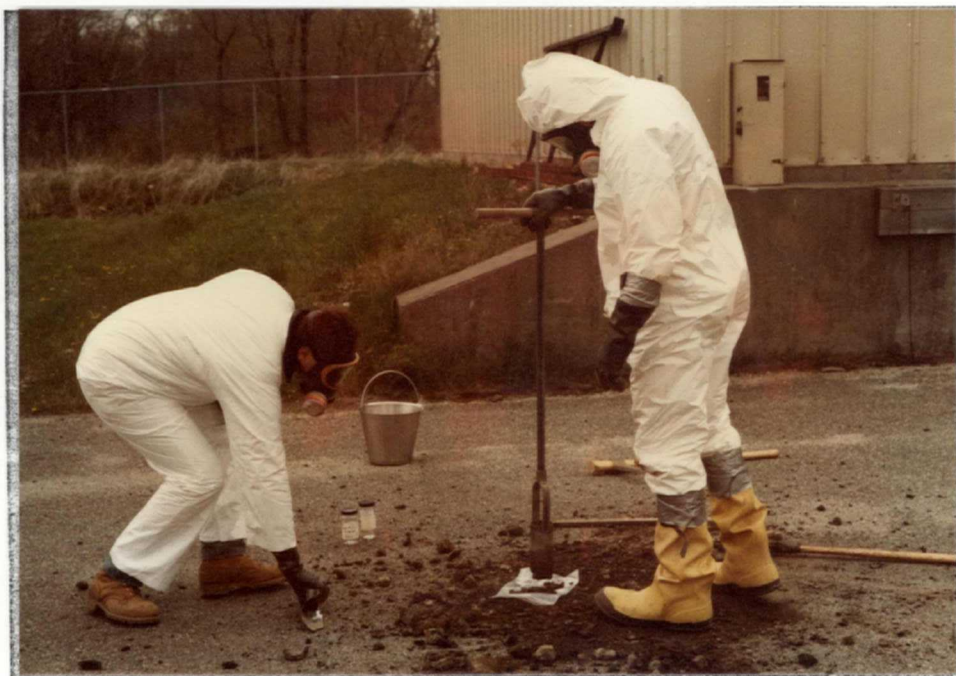
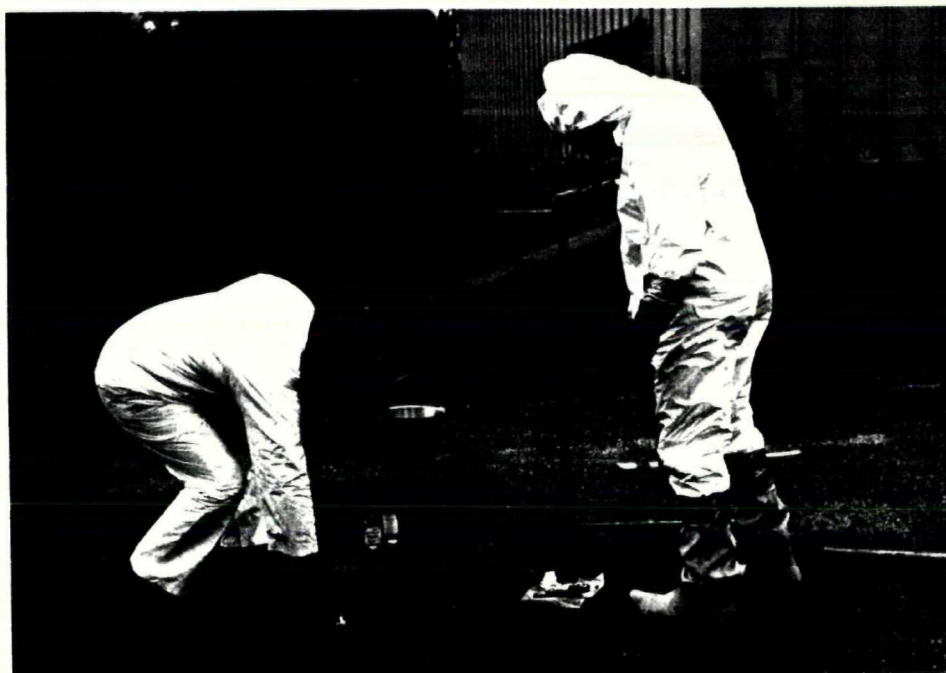
11. 5/16/84 1125 Hours Sample I.D. No. SOIL-5  
Subsurface soil sample taken from beneath the pave-  
ment covering the former disposal pad area, north  
of the enclosed shed.

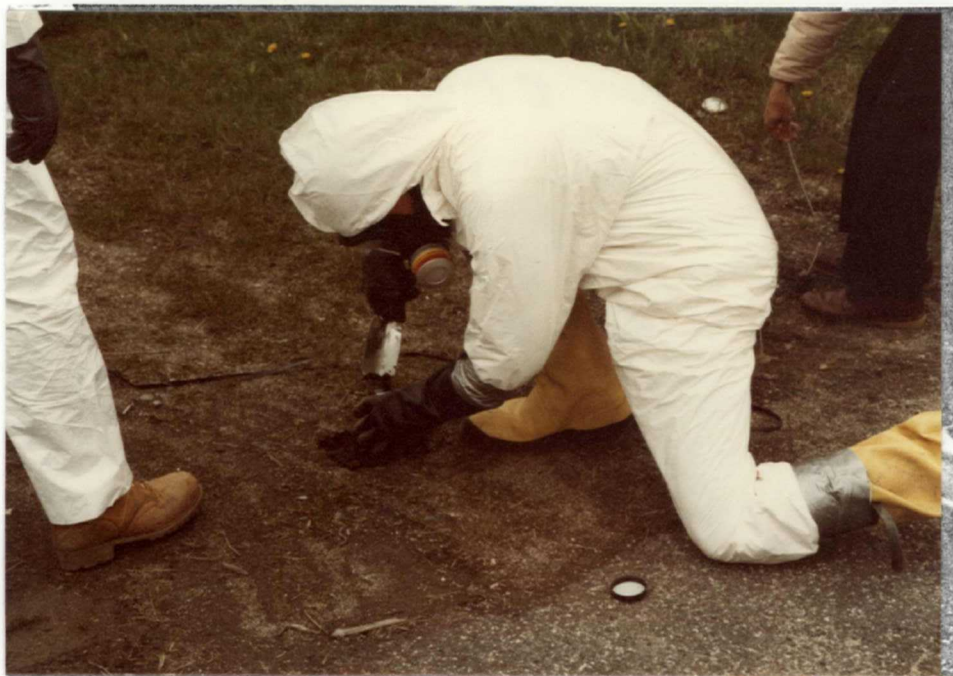
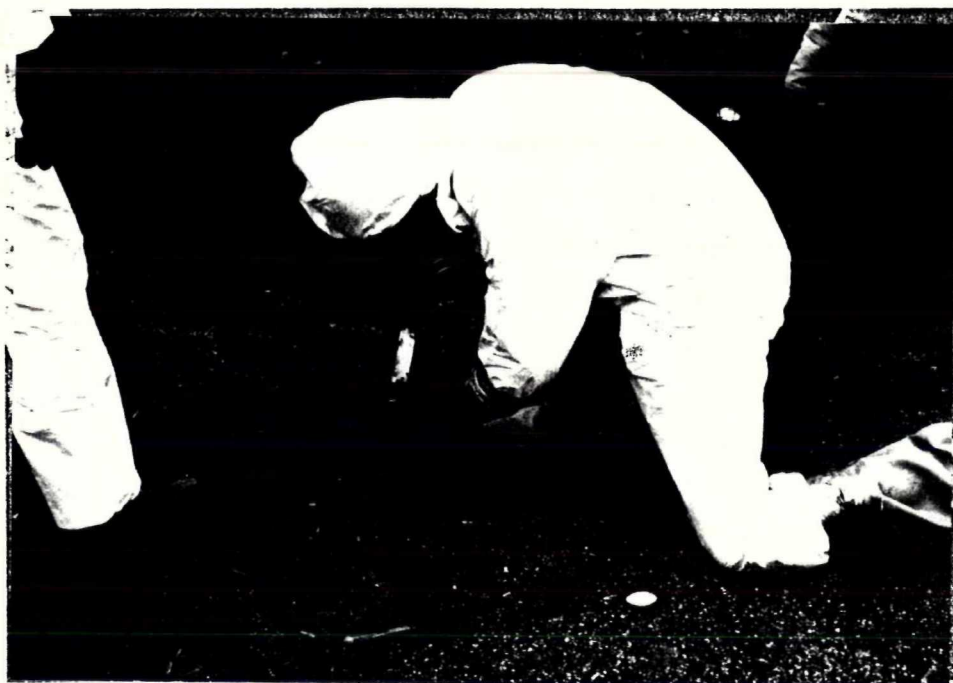
12. 5/16/84 1105 Hours Sample I.D. NO. SOIL-6  
Surface soil sample taken at the intersection of  
the parking lot and the northeast corner of the  
enclosed shed.

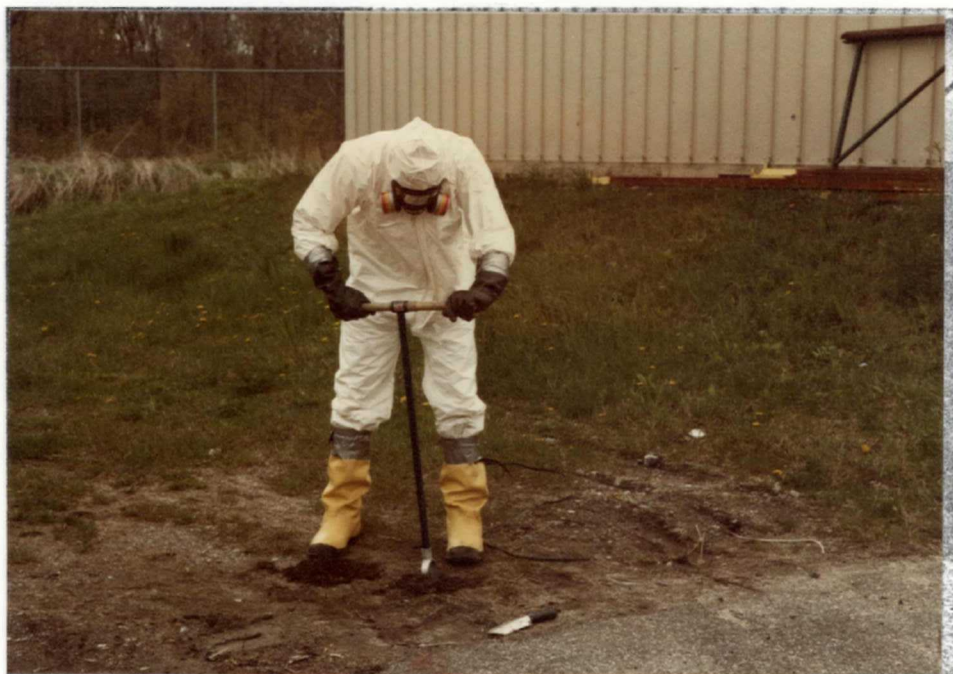
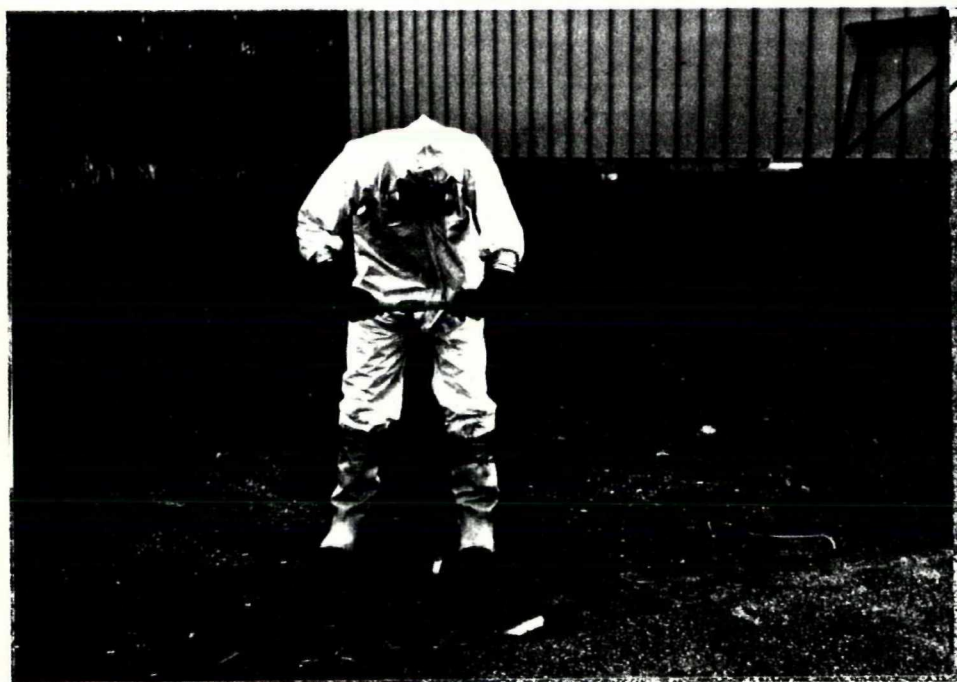
13. 5/16/84 1115 Hours Sample I.D. No. SOIL-7  
Subsurface soil sample, same location as above.

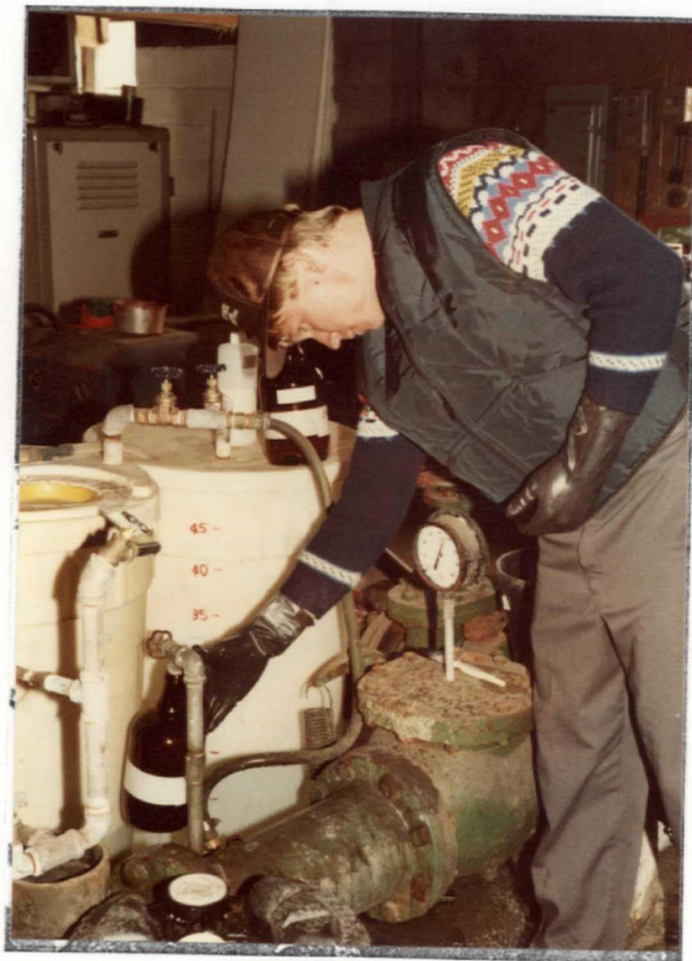
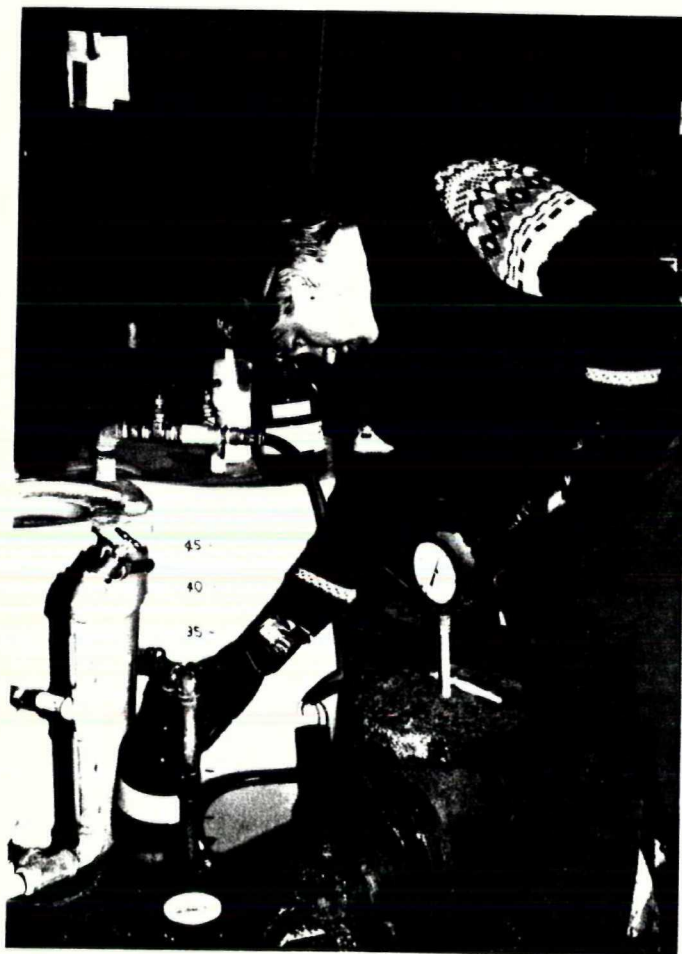
15. 5/16/84 1400 Hours Sample I.D. No. GW-2  
Groundwater sample taken from the tap at the  
Millerton Municipal Water Supply building (after  
chlorination treatment).

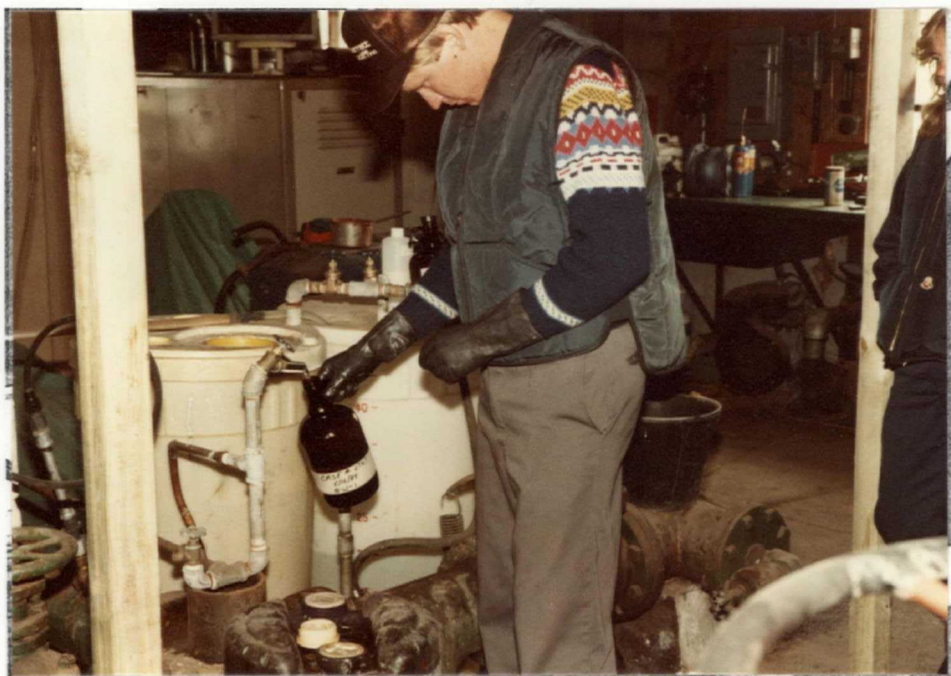
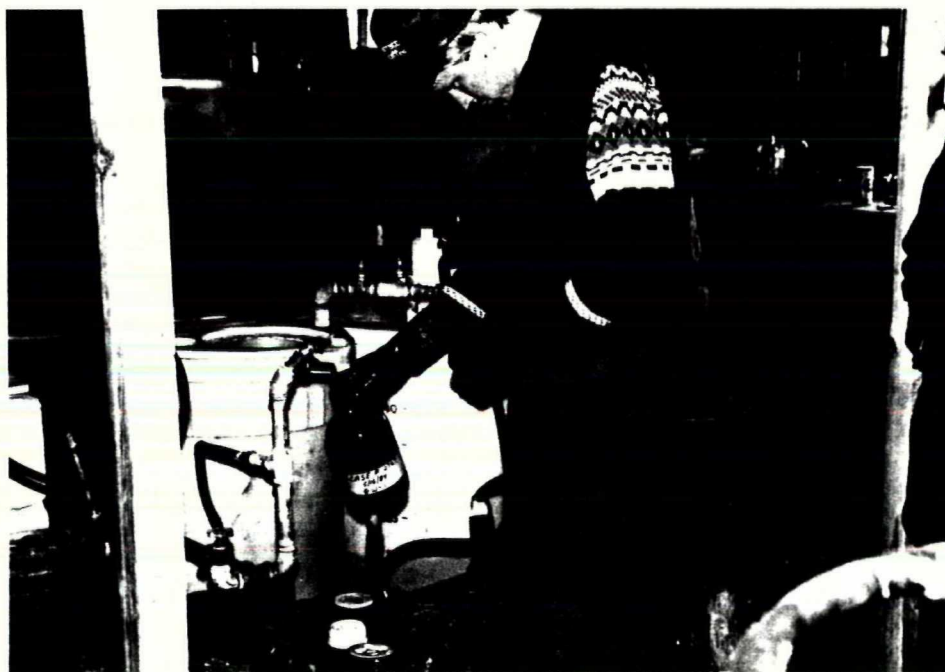
14. 5/16/84 1350 Hours Sample I.D. No. GW-1  
Groundwater sample taken from the well head at  
the Millerton Municipal Water Supply building  
(before chlorination treatment).
